HISTORIC PRESERVATION CERTIFICATION  
APPLICATION—PART 1

1. Name of property: 1618 West Lexington StreetAddress of property: 1618 West Lexington StreetCity Baltimore County \_\_\_\_\_ State Maryland Zip Code 21223Name of historic district in which property is located: Franklin Square Historic District

HISTORIC PRESERVATION CERTIFICATION APPLICATION - PART 1  
1618 WEST LEXINGTON STREET  
FRANKLIN SQUARE HISTORIC DISTRICT  
BALTIMORE CITY, MARYLAND

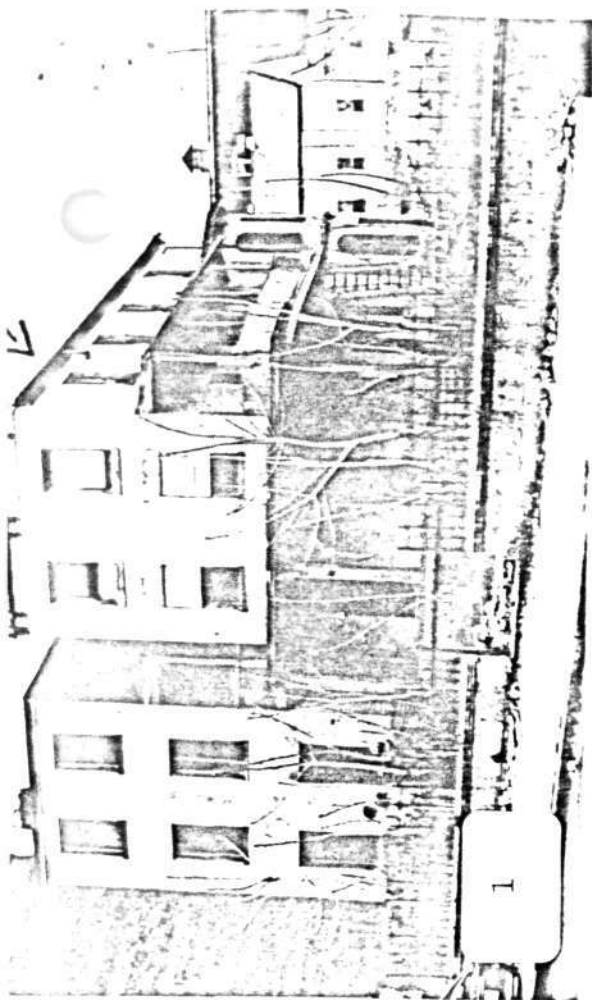
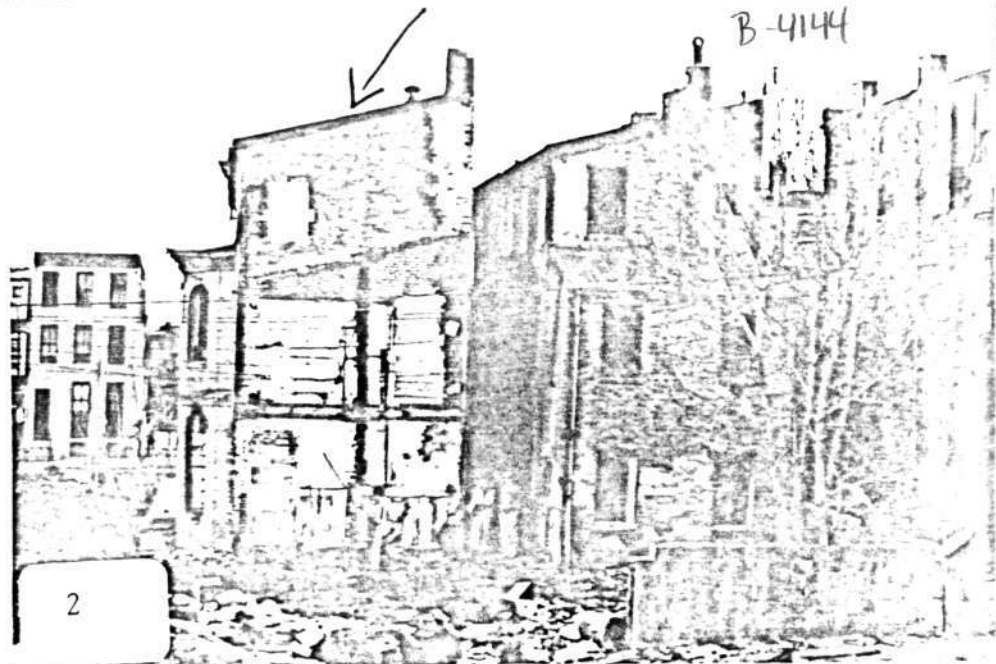
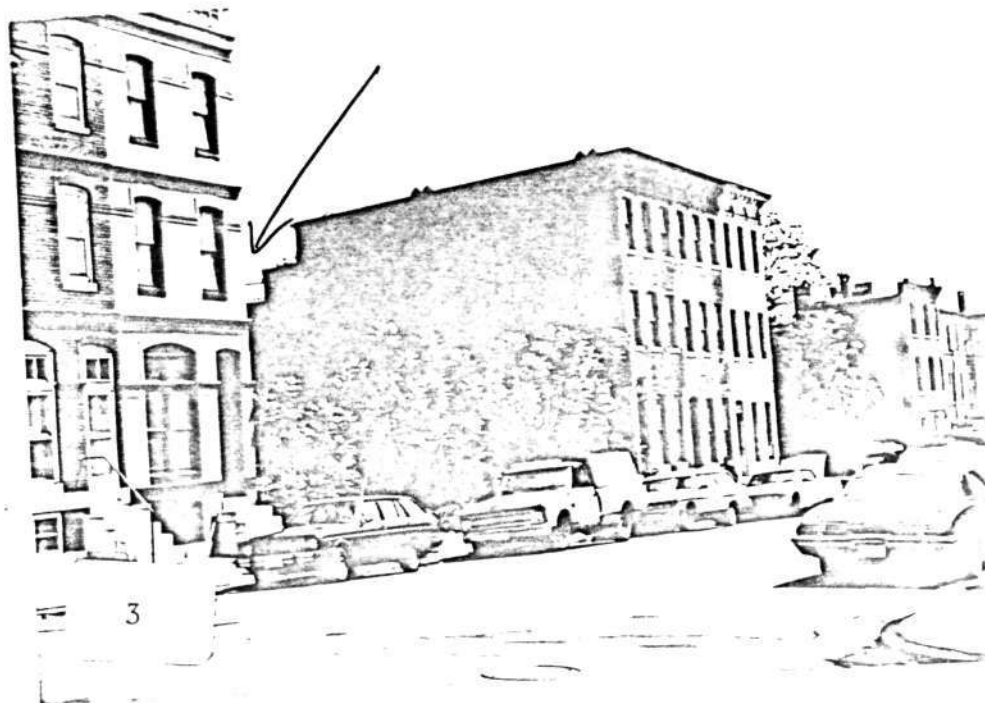
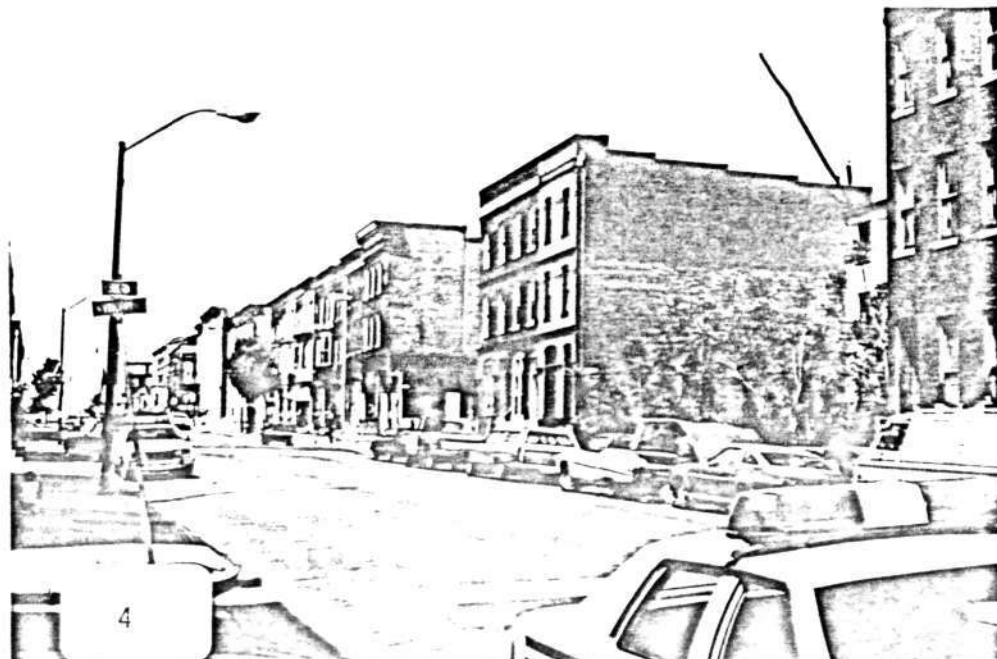
Three story detached brick house with unfinished basement. A porch is attached to the front first floor and runs half way down the east side of the house with a second story porch above the east side area. (continued)

2. A cornice tops the front third story and the second story bay window. Bathrooms and kitchen have been removed. There is a central and rear staircase from which banisters and newel posts have been removed. Each of the three stories has three rooms. The original plaster walls are either torn down or in considerable disrepair. The floors have been partially torn out. There were three fireplaces (one on each floor) which have been closed and only the left verticle molding on the third floor remains of the three mantles which were once in the house. Three openings in the rear of the house (one on each floor) have been closed with cinderblock. It appears there was a two story frame addition which has been completely removed. See attached photographs 1, 2, 3, and 4.

3. damage and vandalism, unique door casings, some floor moldings and chair rail moldings remain. Although some of the exterior brick in the rear northeast corner and in the first story bay windows has been removed, most of the brick exterior facade can be repointed and repainted. A second cornice tops the second story bay windows. The house is certainly unique in the District which is characterized by rowhouses. See photographs 1, 2, 3, and 4.
